Mechanical rehabilitation of a horizontal filter well in Moers using the High Pressure Impulse-Process® brings about a sustainable improvement.

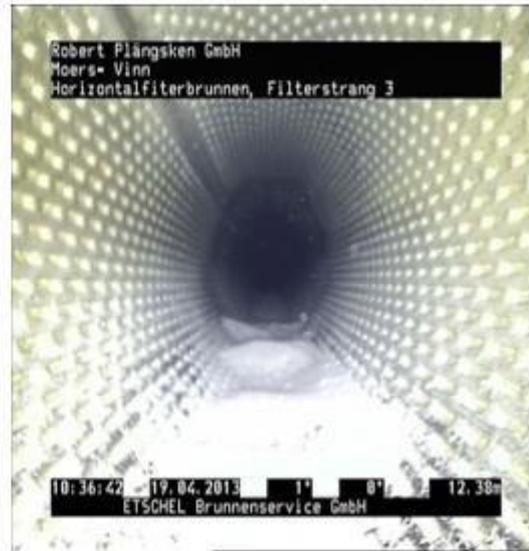
When planning the well "Vinn", the pumping capacity was designed for 800 m³ /h. In advance, the team of the Etschel Brunnenservice was informed that the well strings show no or little signs of ochre depositions, which is due to a low content of iron and manganese in the groundwater. The main reason for a decrease in yield and wear of material was attributed to a sand intrusion in the filter area.

TV before JET Master® rehabilitation shows silt and fine sand deposits on the screens and in the gravel pack

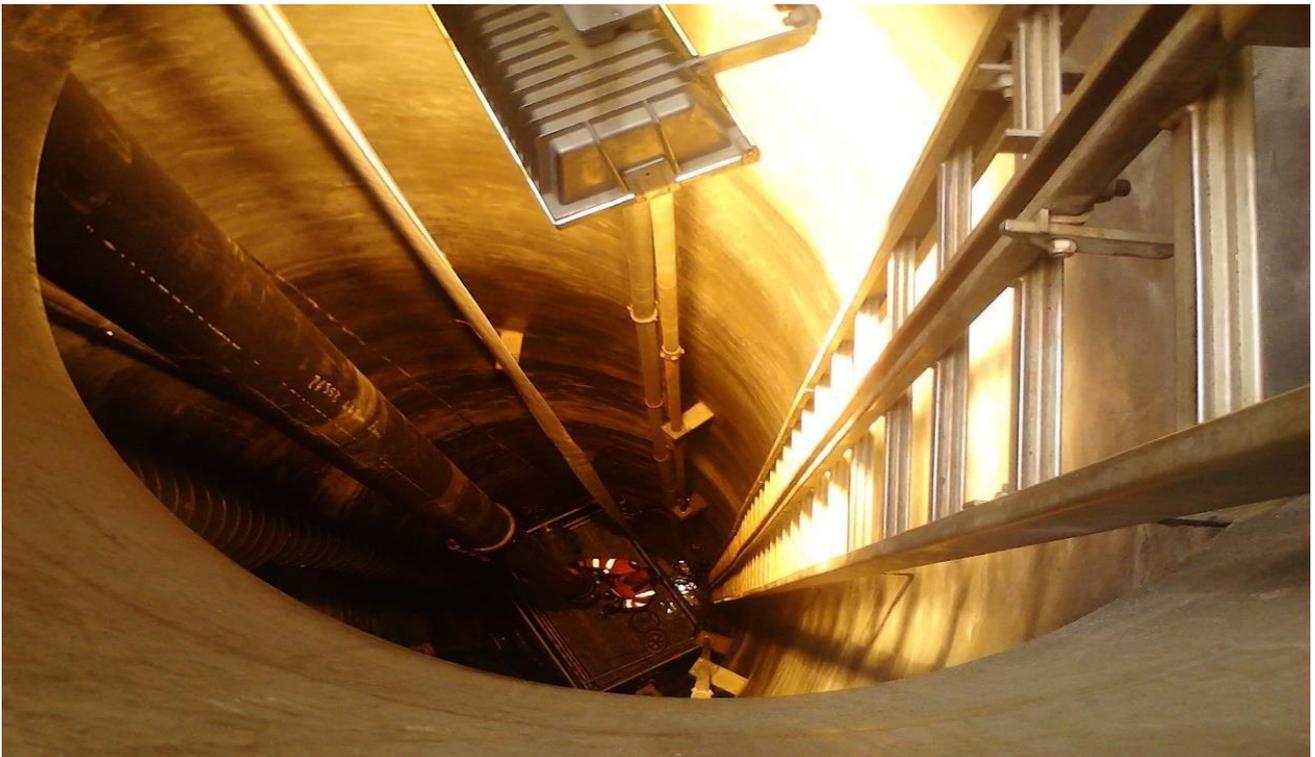
Figure 4: drained well shaft of a horizontal filter well

First, the pumps were removed and the shaft was drained by Plängsken by removing the individual horizontal filter caps.

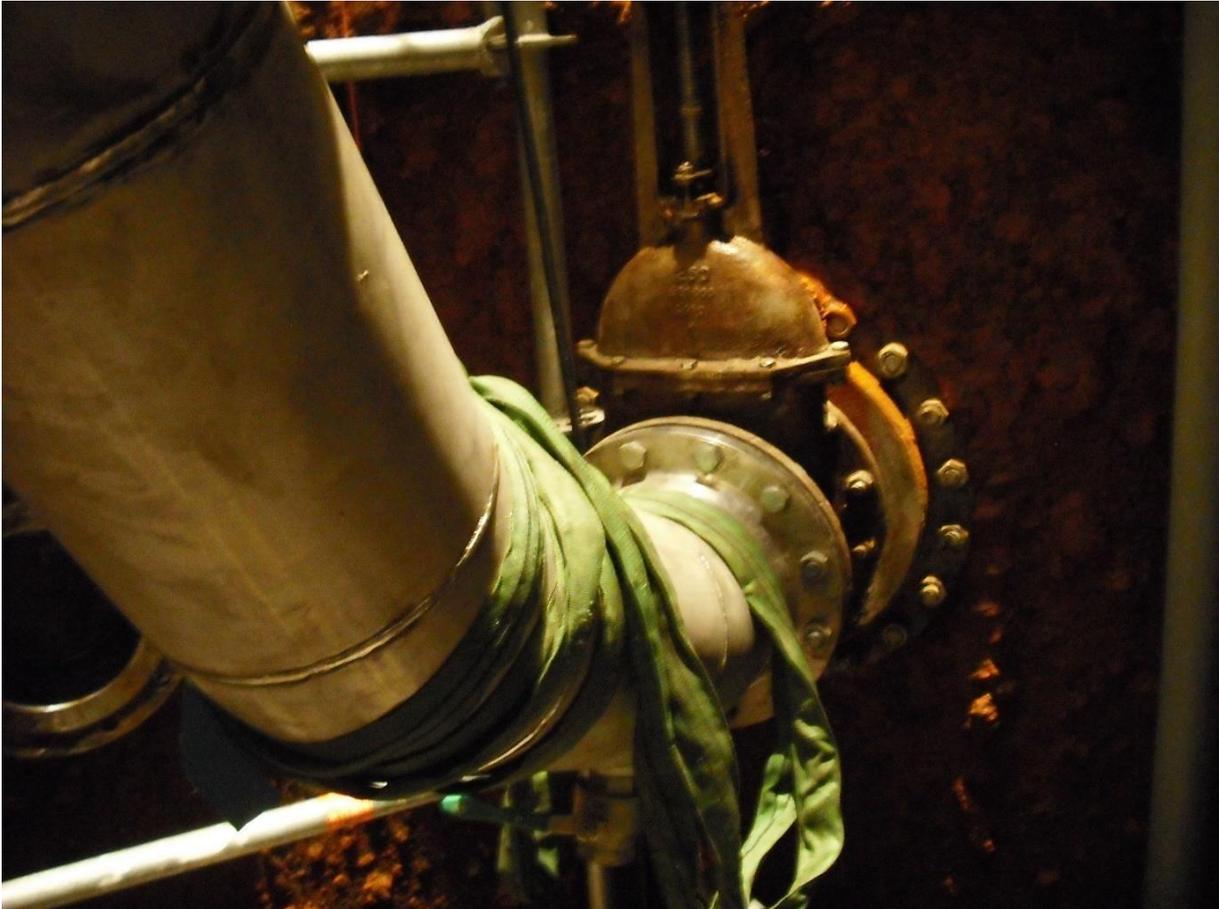
Figure 5: pipeline construction for installing and removing the rehabilitation equipment.

In preparation for the rehabilitation of the horizontal filter strings, Plängsken designed a pipeline which allowed the HPI equipment and the TV camera to be moved into the individual strings for inspection and carrying out the rehab process.

The simultaneous discharge of the dissolved solids during the application of the **HPI-Process®** was also ensured by this pipework. After reaching the finishing criteria, the piping system was moved to the next filter string.

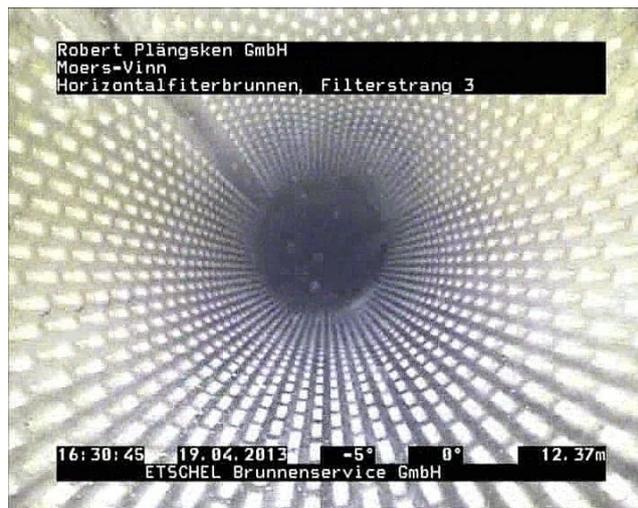
Figure 6: Cleaned string after JET Master® rehabilitation.

The rehabilitation process was carried out, after an obligatory camera inspection, by means of different high-pressure water nozzles. In order to transfer the effectiveness of the water pressure to the immediately adjacent filter gravel and the adjacent geology, the nozzle head is rotating and can thus mobilize undersized particles and precipitates in the grain structure by the force of the generated impulses of pressure waves. The underpressure generated by the high rotational speed caused the simultaneous suction of the dissolved solids into the horizontal string, from where they were pumped out simultaneously. The quantities of solids released in the process were clearly documented by measurements in Imhoff cones and in an overflow basin in accordance with the regulations.

During the rehabilitation process, other nozzle devices were also used, because of the penetration occurring mainly in the rear filter area. Due to the geological conditions and dimensioning of the gravel pack during the rehabilitation of the individual strings of the horizontal well "Vinn", being technical sand free as a termination criteria was not aimed for. Thus, rehabilitation was carried out up to meeting said criteria for termination, i.e. the discharged solids could no longer be removed.

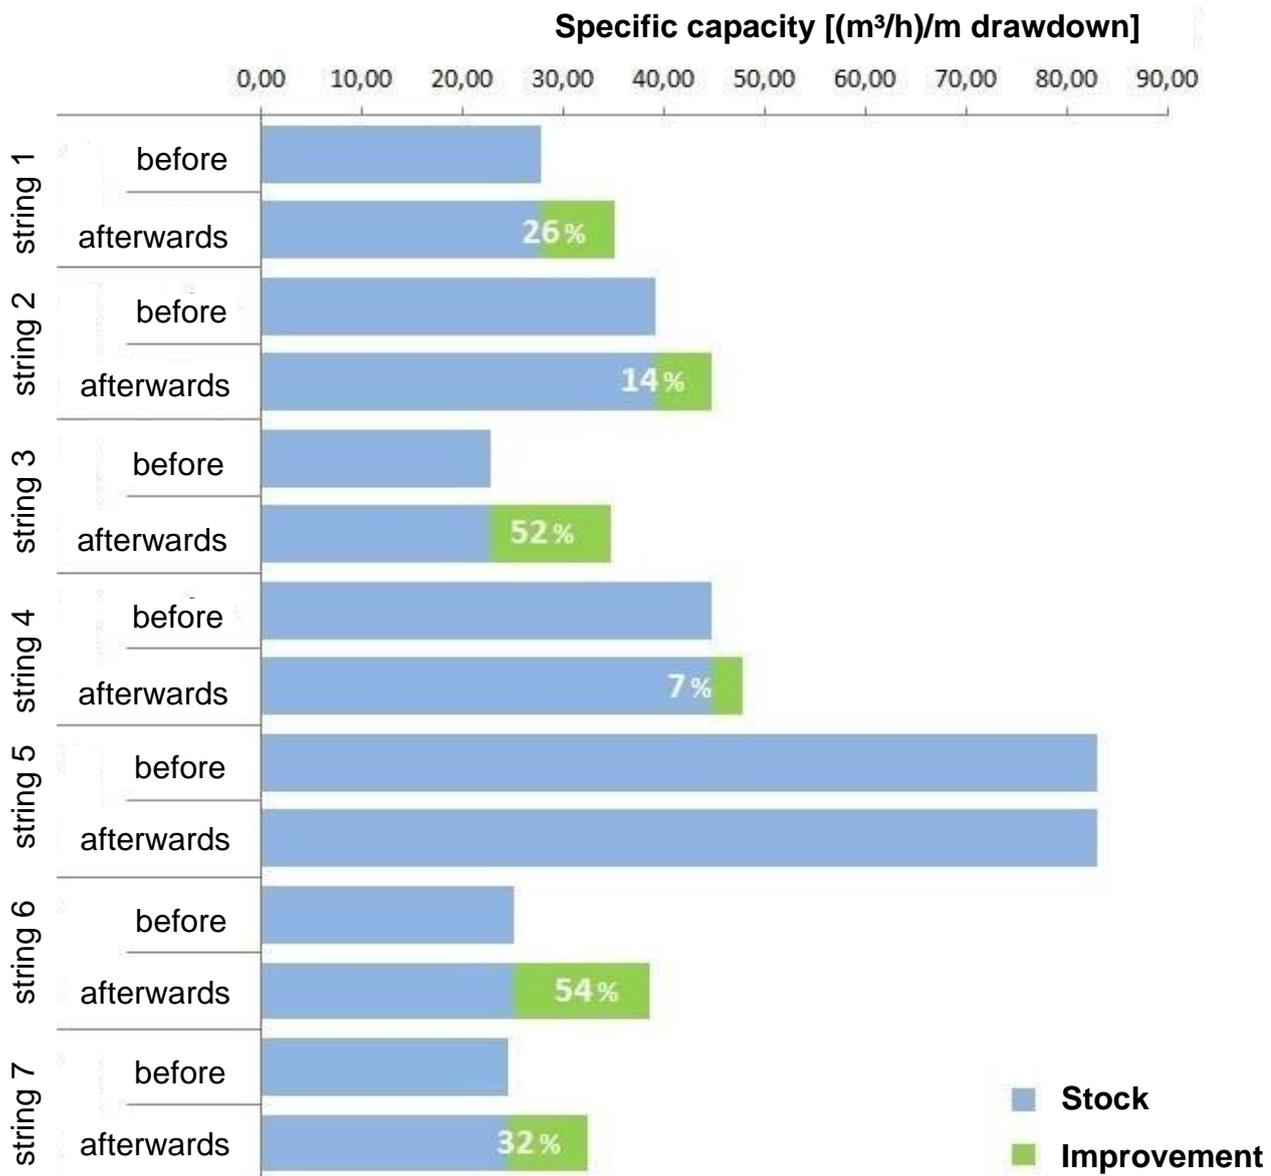
direction showed less sand input. In contrast to this, an increased degree of ochre formation was documented on the strings facing the flow, in addition to the sand input. From the calculation of rest water level and groundwater lowering of the specific yield before, it was shown that strings 4 and 5, which point away from the groundwater flow, have the highest yields of up to 80 (m³/h)/m. Strings 1, 6 and 7, facing away from the flow, were up to half as low.

Figure 7: graphic representation of the specific yield before and after the JET Master® rehabilitation for each string

After rehabilitation using the Etschel **JET Master®** with the **UNINOZ®** rotary nozzle system, the performance of strings 1, 6 and 7 was increased by up to 50%. Strings that had a relatively high specific yield before rehabilitation could naturally only be optimized to a minor extent. After completion of the measure, the temporary installation parts were dismantled by the company Plängskén, the shaft disinfected and the operating pumps reinstalled. A final pumping test by the operator showed an increase of the Q spec. by 21% compared to the pumping test values before the rehabilitation.
